CRS S-8496
Not Eligible
Plate 214; Appendix A, Plat 25

This small, rectangular plan, one story, gable roofed cottage is situated on the east side of Road 30, south of Gravel Hill. The house is three bays wide and two bays deep with a rear, one bay deep, shed roofed addition. The pedimented entry is centrally placed in the west or front facade, facing the road. The doorway is flanked by a modern, one over one, double hung window and a large, picture window. A rear entrance is located in the middle of the east facade. A modern, exterior, brick chimney is placed along the north facade. The house sits on a concrete foundation and is clad in blue, composition shingle siding. Two sheds, one of which is modern, are present at the rear of the property. This house appears to have been built after 1945, and lacks individual architectural merit or known historical significance, thus it is ineligible based on National Register criteria.

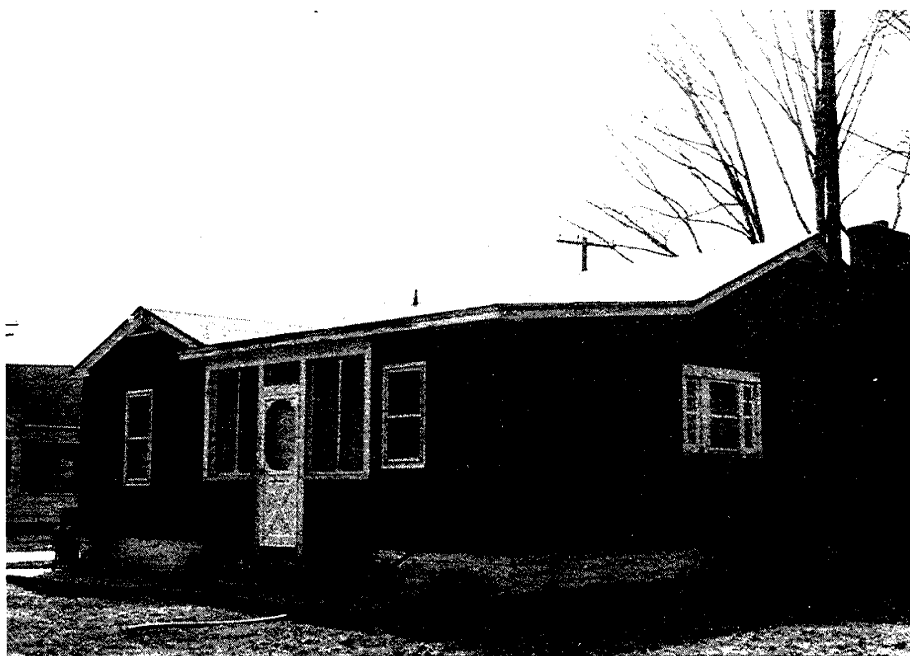
PLATE 214: CRS S-8496
View of rear facade of house facing southwest.

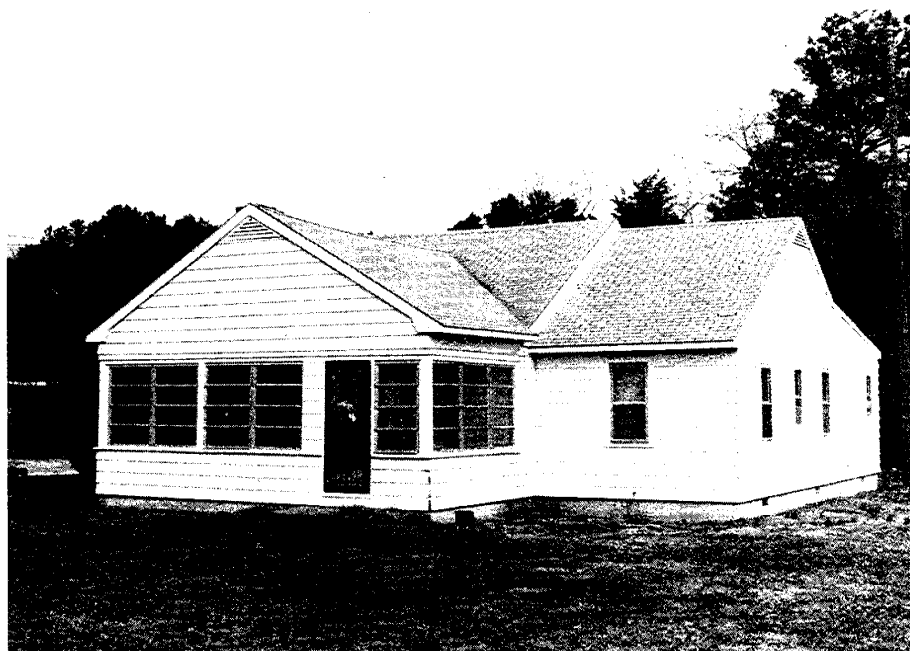
This one story, L-plan, gable roofed cottage sits on the east side of Road 30, south of Gravel Hill. An enclosed porch with bands of modern, louvered windows extends across the front facade. The entrance is located in this porch. All of the remaining windows in the house are one over one, double hung. A shed roofed addition has been built across the rear or east facade. A second entrance is placed in this facade. A modern, brick chimney is positioned along the north facade. An interior, concrete block chimney is located in the shed roofed, rear addition. The house sits on a concrete foundation and is clad in aluminum siding. This house appears to have been built after 1945, and lacks individual architectural merit or known historical significance, thus it is ineligible based on National Register criteria.

PLATE 215: CRS S-8497
View of house looking east.

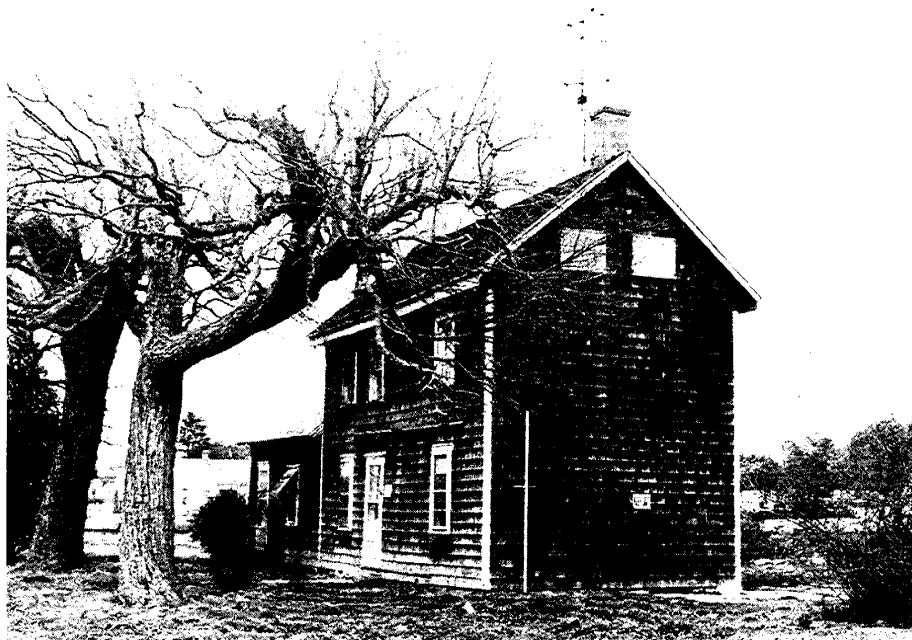
This previously surveyed, late nineteenth century dwelling complex is situated on the east side of Road 30, in Bennum. It is adjacent to the Delaware Coast Railroad tracks. The I-house is two and one-half stories, three bays wide and one bay deep with a gable roof and a one story, two bay wide addition on the north facade. The house is covered in wood shake, shingle siding and is currently for sale. A frame corncrib and shed are located on the property.

PLATE 217: CRS S-3163
View of I-house looking north.
Note wood shake shingle siding and attic windows (covered over).

This complex appears to be eligible as a contributing part of the proposed, Three Bay, I-House, Multiple Property Submission. Although the house is abandoned, it does retain its basic form and six over six windows, as well as a Federal style door surround in the main entrance, a brick foundation, and two original outbuildings. Three bay I-houses are significant remnants of the basic vernacular dwelling type found throughout Sussex County. The majority of the houses included in this submission, including this one, were part of working agricultural complexes, and thus is also significant under the priority theme of Agriculture (Ames et. al. 1989:79, 83).

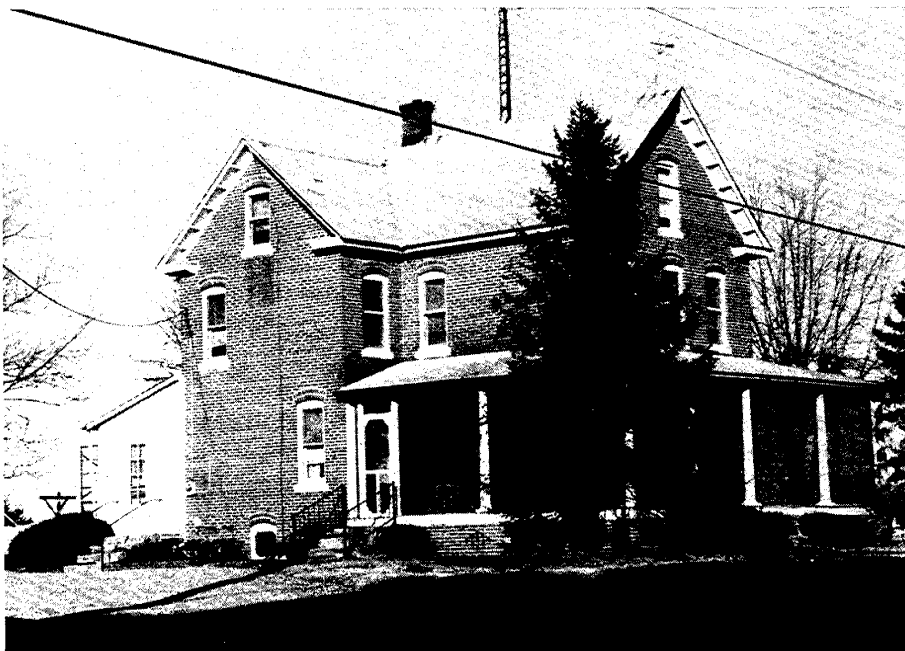
PLATE 219: CRS S-3618
View of house looking north. Note brick construction and arched window lintels.

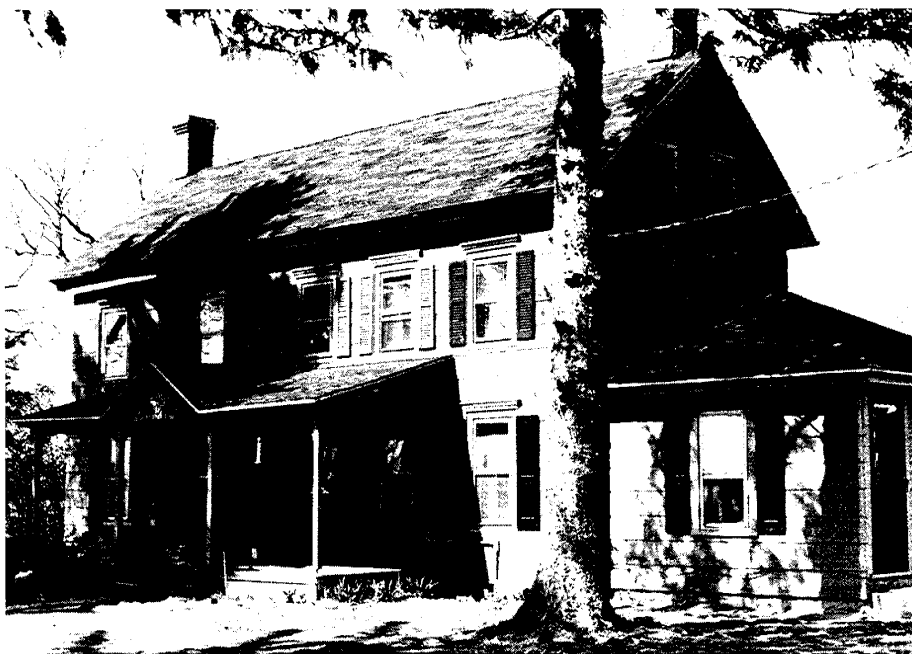
PLATE 220a: CRS S-3617

View of house looking northeast. Note symmetrical five bay fenestration and interior end brick chimneys.

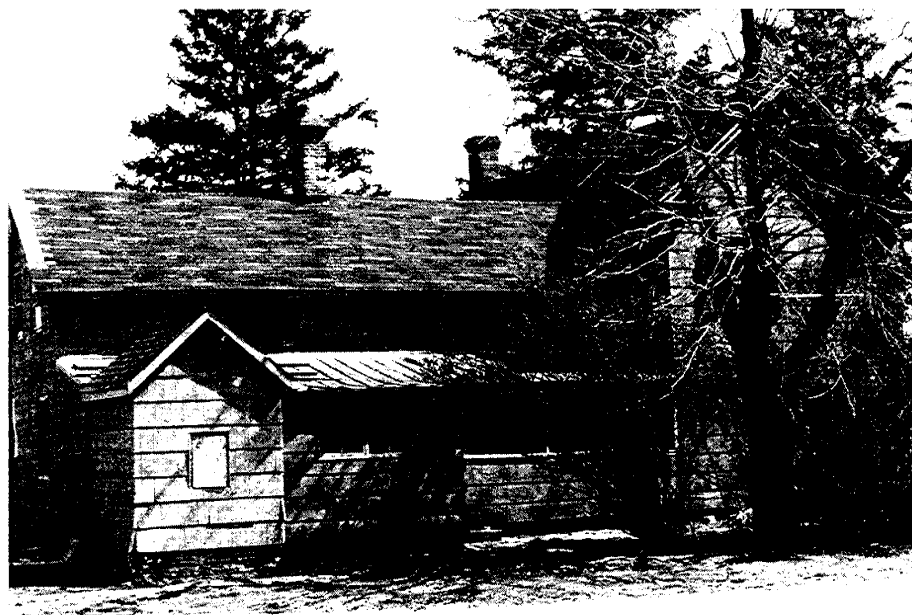
PLATE 220b: CRS S-3617

View of rear wing looking south. Note bake oven with brick foundation in the foreground.

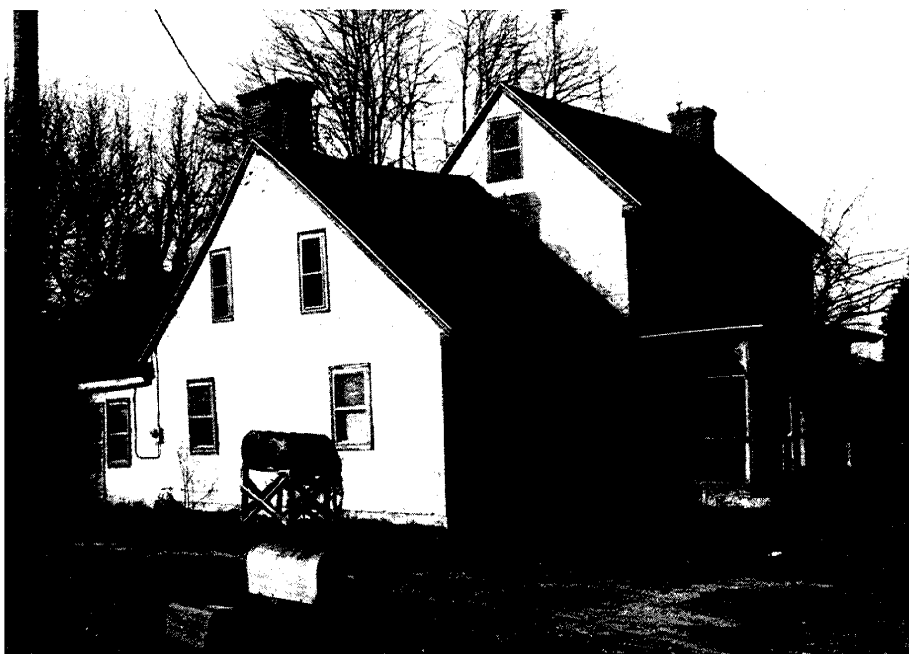
PLATE 221a: CRS S-2912

View of house looking northwest. Note three different sections representing three building stages.

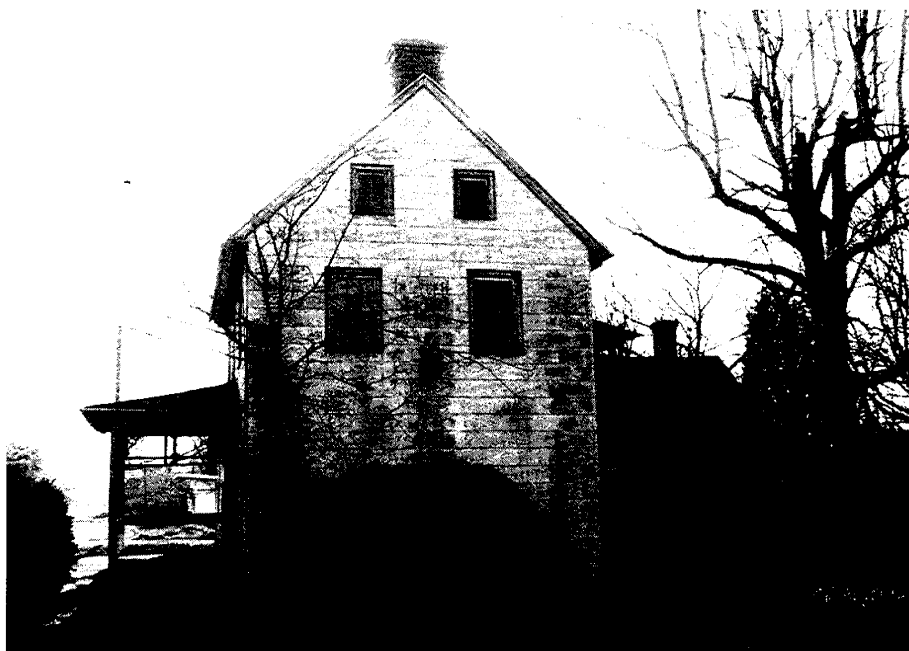
PLATE 221b: CRS S-2912

View of north facade of house. Note six over six, double hung windows in the second story and small, four square windows in the attic story.

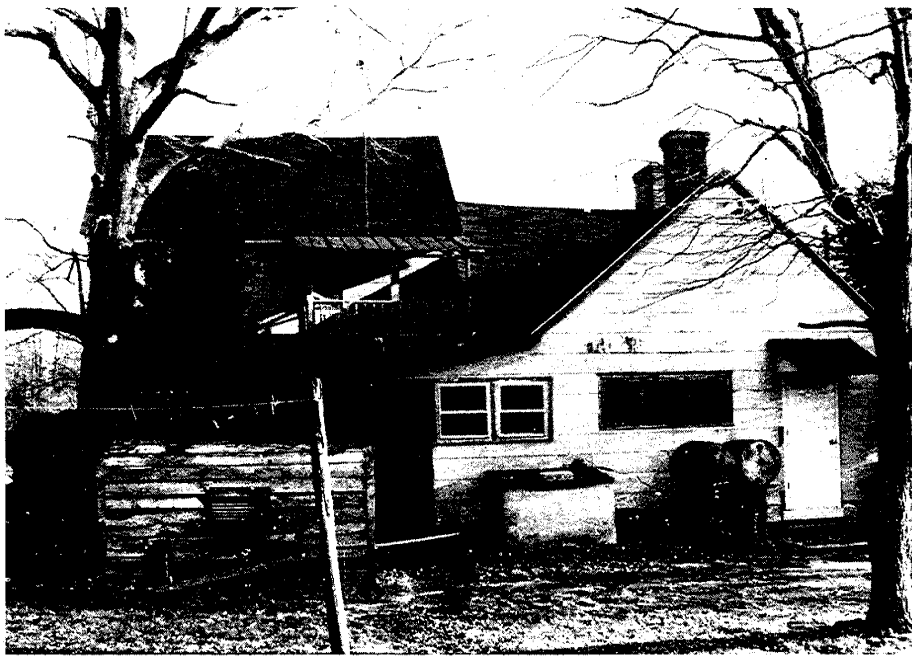
PLATE 221c: CRS S-2912
View of rear facade of house and attached kitchen wing. Note corbeled brick chimneys.

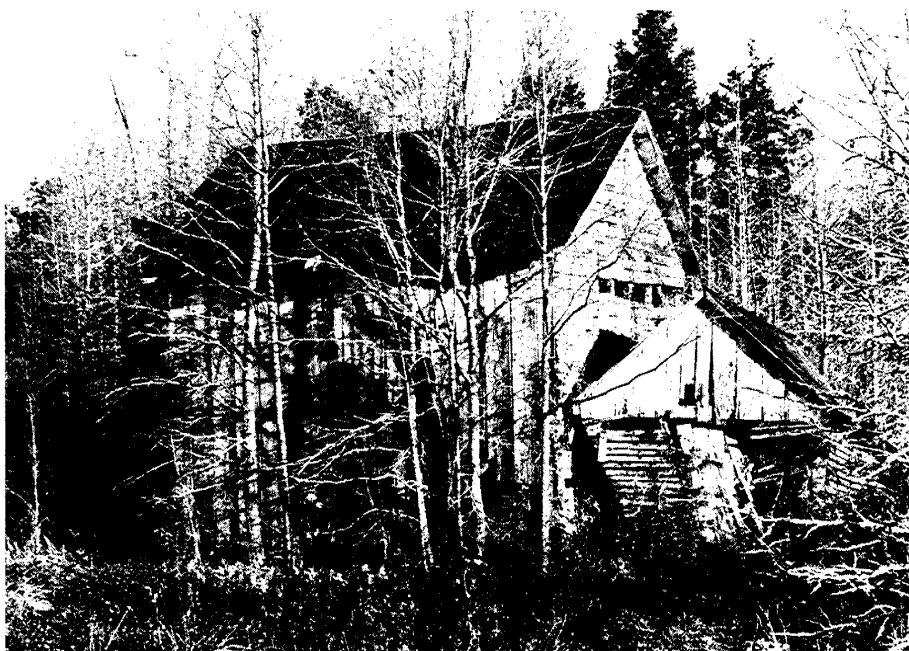
PLATE 221h: CRS S-2912
View of deteriorated outbuildings across Road 5, east of the house.
The smaller building appears to be a corn crib.

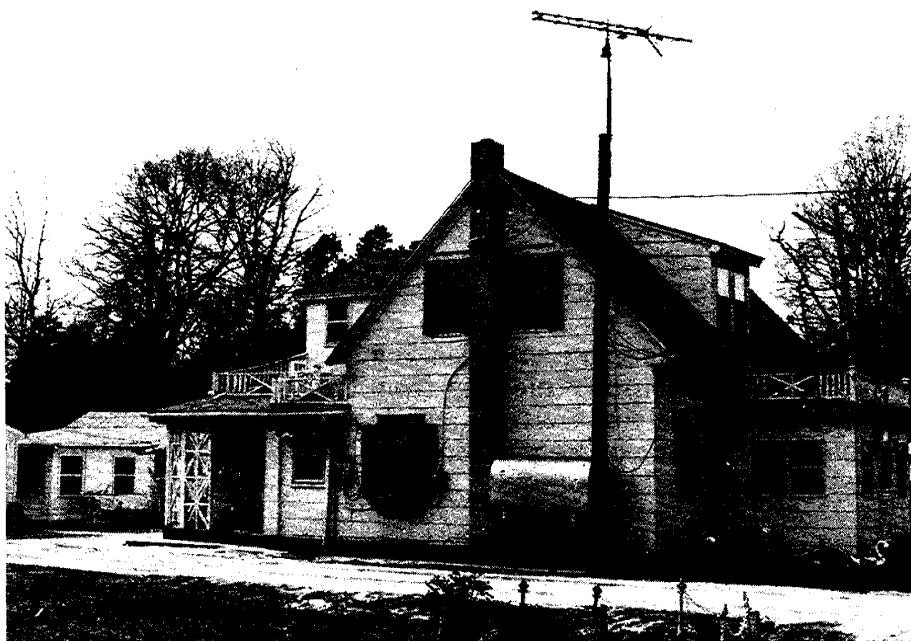
PLATE 222: CRS S-8500
View of cottage looking northwest. Note modern shutters and wooden balustrades.

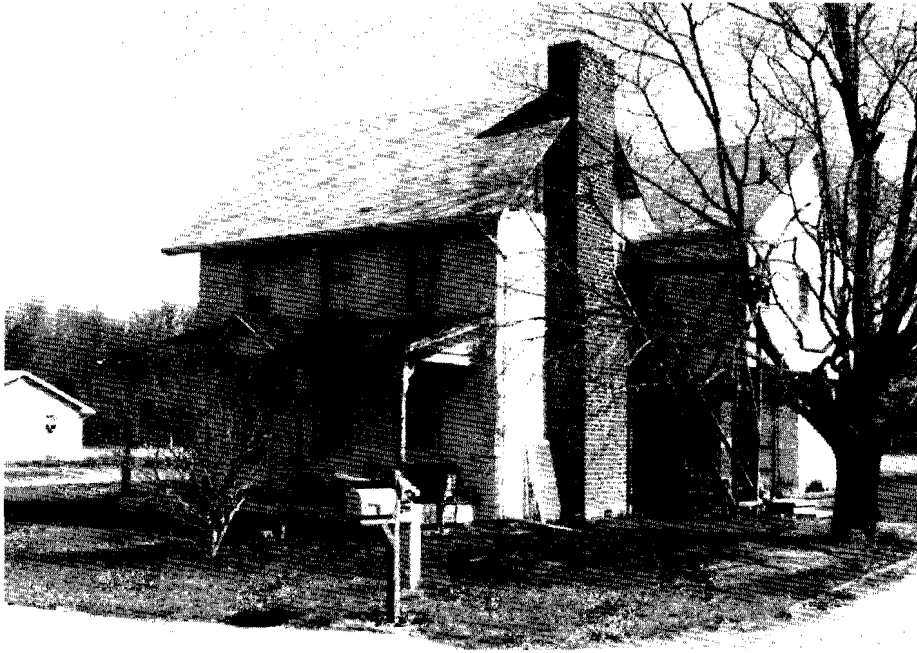
Today, the building is in fair condition and has been heavily altered by a large, obtrusive rear addition. This addition greatly detracts from the overall integrity of the house and overwhelms the original, three bay I-house. There are better examples of the three bay I-house found throughout the project corridor, of which the best examples were selected for inclusion in a multiple property submission. The building is not eligible.

PLATE 243: CRS S-3022
View of house looking northeast. Note modern chimney and large rear addition.

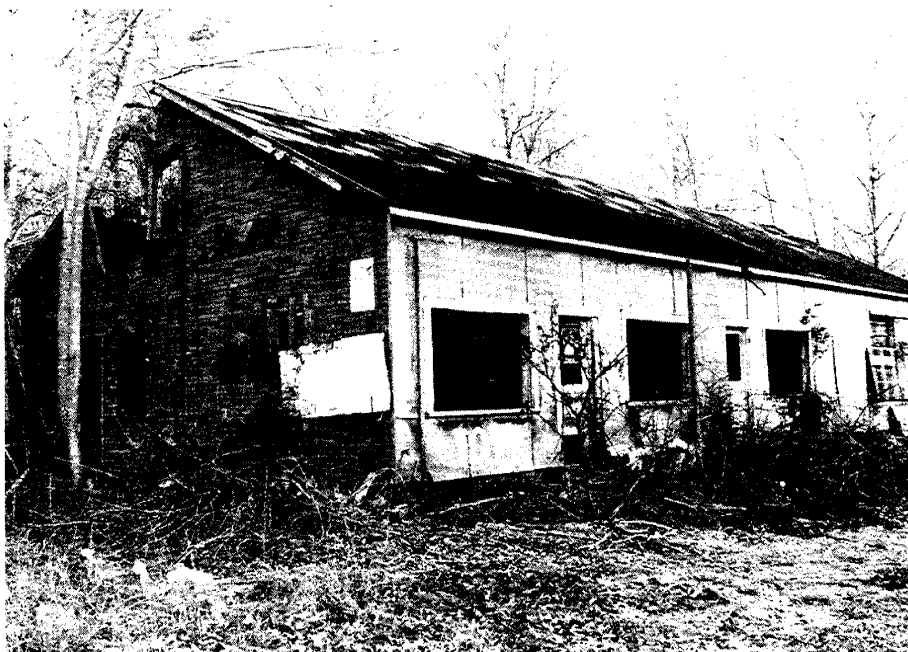
PLATE 247a: CRS S-8511
View of abandoned store looking northeast.

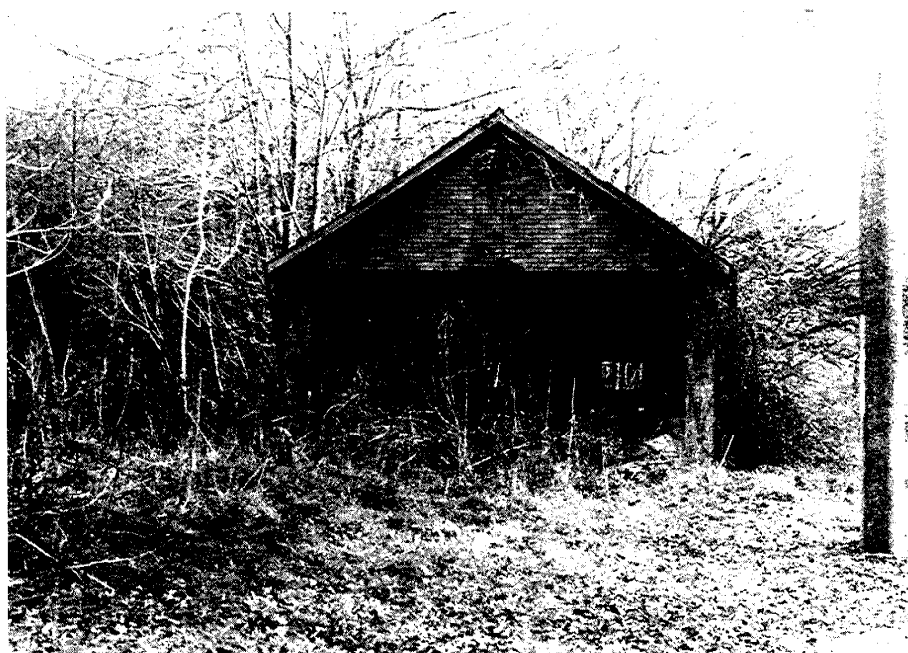
PLATE 247b: CRS S-8511
View of abandoned garage, just east of abandoned store.

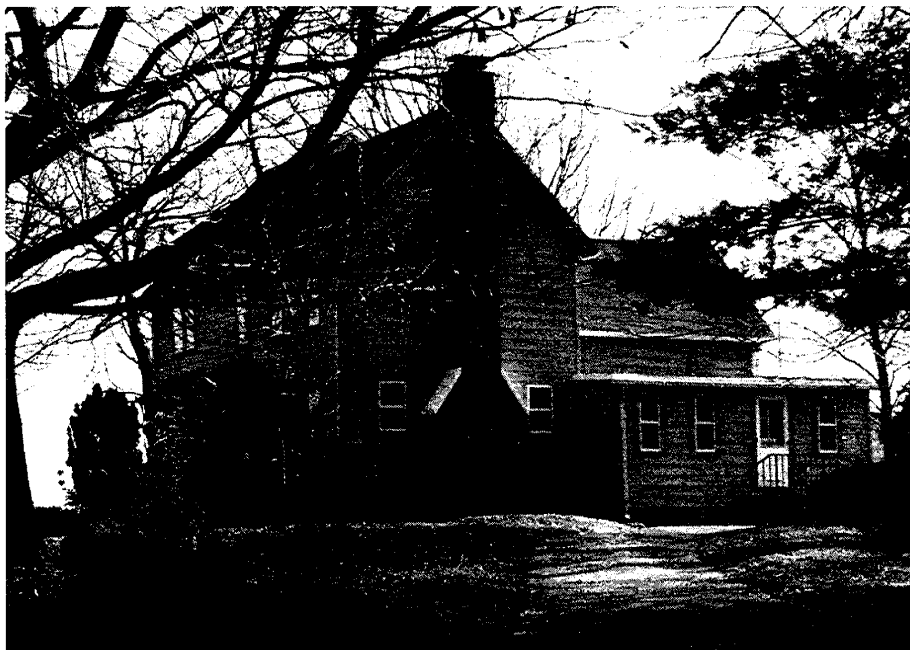
PLATE 253: CRS S-857
View of house looking southeast. Note modern chimney and changes in the fenestration.

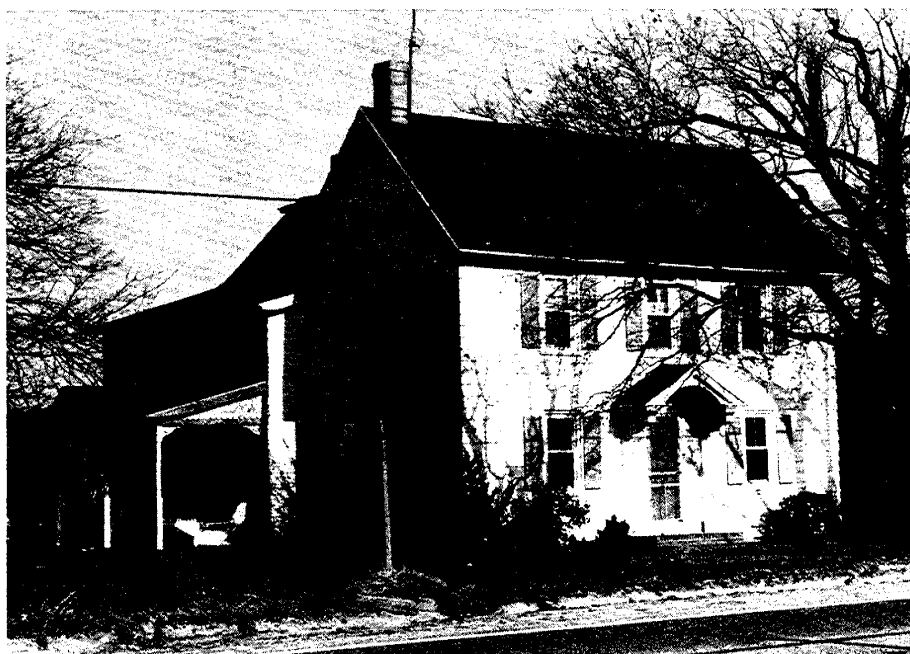
PLATE 254: CRS S-859
View of south and west facades of the house. Note added Colonial Revival details and the large addition on the rear facade.

This property does not appear to be eligible either individually, or as part of the Three Bay, I-House, Multiple Property Submission. Alterations to the building's exterior include, louvered shutters on the windows and front door; a shed roofed, enclosed addition on the east facade of the rear wing, that has a band of two, modern picture windows; and the replacement of the small, attic story windows with ventilator openings. Although the house is in good condition, the above mentioned alterations coupled with the fact that there are no extant historic outbuildings, detract from the overall integrity of the house.

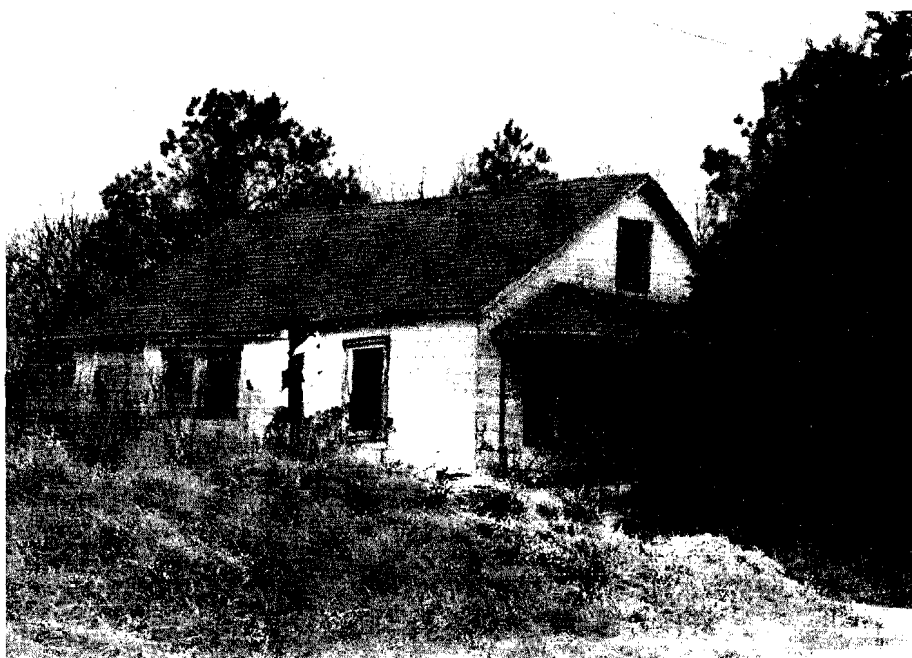
PLATE 262: CRS S-899

View of abandoned cottage looking southeast.

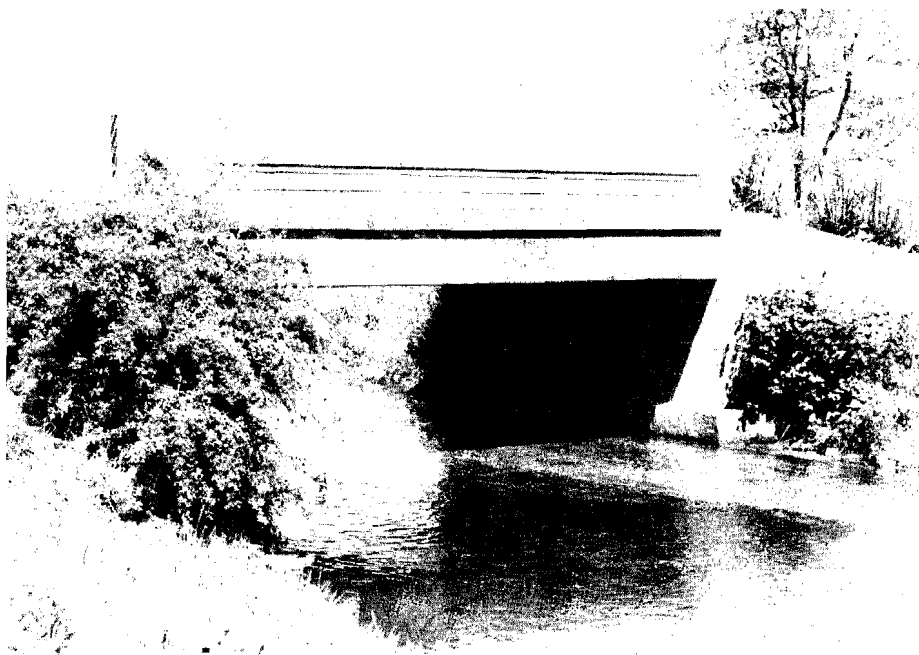
PLATE 269: CRS S-3992
View of bridge over Nanticoke Branch on Road 600, east of Bridgeville.
The bridge was constructed in 1930.
